FINAL
NORTH RIVER BASIN
PEABODY, MASSACHUSETTS

**SPRING POND DAM
MA 00193**

**PHASE 1 INSPECTION REPORT
NATIONAL DAM INSPECTION PROGRAM**

DECEMBER 1978

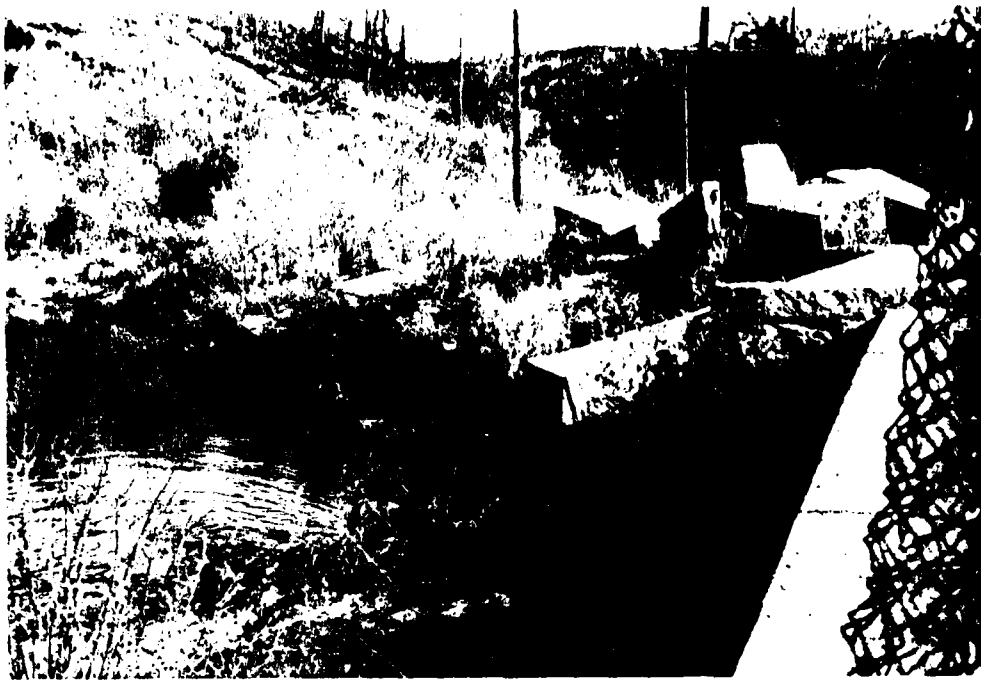
The downstream slope is in generally good condition except that there are several gullies, probably caused by run-off and/or pedestrian traffic. The surface of the slope is overgrown with numerous saplings, tall grass and bramble bushes. Several concrete slabs about 10 feet long and 12 inches wide, reportedly remnants of the old gatehouse roof, have been placed on the slope. (See Photograph No. 4).

VIEW OF DOWNSTREAM SLOPE. NOTE VEGETATION.

5. Remove all brush, shrubs and young saplings from both slopes and the crest.
6. Refill areas of erosion and gullies on the downstream slope and crest.
7. Replace stones missing on upstream riprap slope protection.
8. Traffic on the crest should be eliminated. If this is not practical, consideration should be given to paving the crest.
9. Consideration should be given to relocating the high voltage transmission tower off the dam crest.

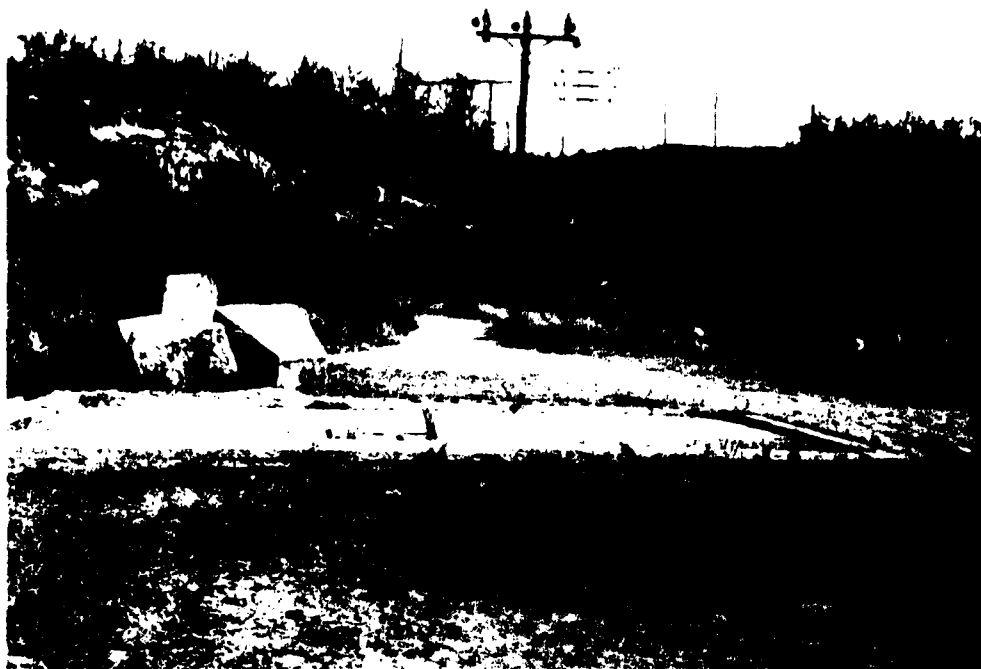
The earth embankment appears to be in generally good condition. The horizontal alignment of the crest is generally good and the vertical alignment is also good except for some depressions and ruts which have been created by traffic, especially trail bikes. (See Photograph No. 2). There is a high voltage transmission tower and a telephone pole located on the crest of the embankment. (See Photograph No. 2). Several concrete blocks were observed on the crest. It is reported that these will be placed, at some future date, on the upstream slope as additional slope protection. (See Photograph No. 2).

2. VIEW OF CREST. NOTE REMNANT OF GATE HOUSE IN FOREGROUND AND HIGH VOLTAGE TRANSMISSION TOWERS.

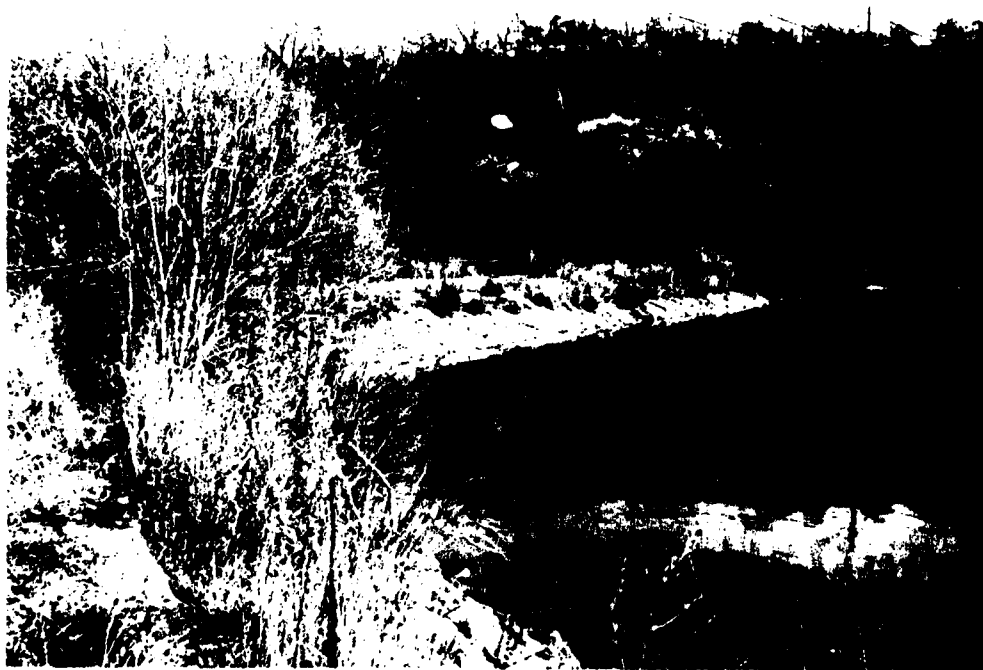
The upstream slope is in generally good condition. The cemented riprap is in good condition, however, the cemented section of riprap extends only little more than half way along the length of the embankment. The remainder of the slope protection consists of uncemented riprap. In this area some stone is missing, and others have been displaced. There are saplings, tall weeds, brush and grass growing through the riprap. (See Photograph No. 3). Two 8-inch diameter pipes located on either side of and parallel to the spillway and about one foot below the dam crest were observed. Reportedly these pipes had been used as overflow pipes but have since been plugged.

3. VIEW OF UPSTREAM SLOPE. NOTE CEMENTED STONE RIPRAP AND VEGETATION.
